Final Report

New Jersey Traffic Signal Retiming Project

Church Street/Maple Avenue (CR 607) State Route 38 to Locust Avenue

Greentree Road (CR 674) NJ Route 73 to Church Road (CR 616)/Hainesport-Mount Laurel Road

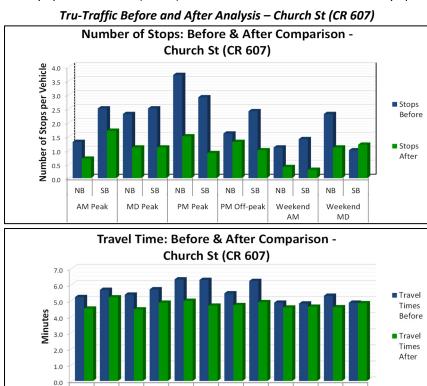
Field measured travel time runs were conducted on Church Street/Male Avenue (CR 607) between Locust Avenue and Pleasant Valley Avenue. In the northbound direction, weekday travel times decreased by up to 80 seconds (21.1%) and weekend travel times decreased by up to 43 seconds (13.5%). In the southbound direction, weekday travel times decreased by up to 96 seconds (25.5%) and weekend travel times decreased by up to 12 seconds (4.2%).

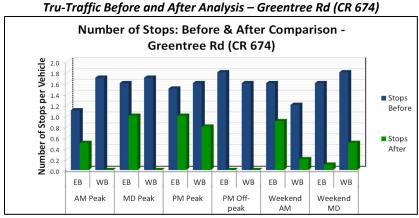
Field measured travel time runs were conducted on Greentree Road (CR 674) between Lincoln Drive and Church Road (CR 616). In the eastbound direction, weekday travel times decreased by up to 68 seconds (40.2%) and weekend travel times decreased by up to 92 seconds (45.3%). In the westbound direction, weekday travel times decreased by up to 128 seconds (55.9%) and weekend travel times decreased by up to 100 seconds (46.7%).

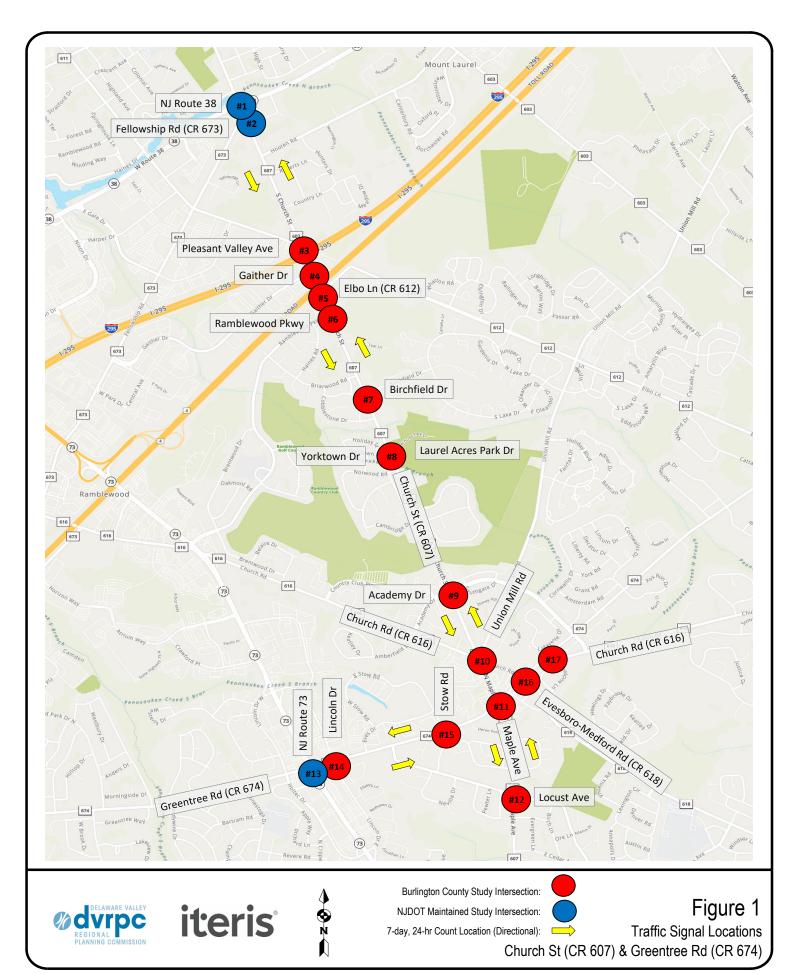
Figure 1 on page 3 illustrates the locations of the signals included in this report.

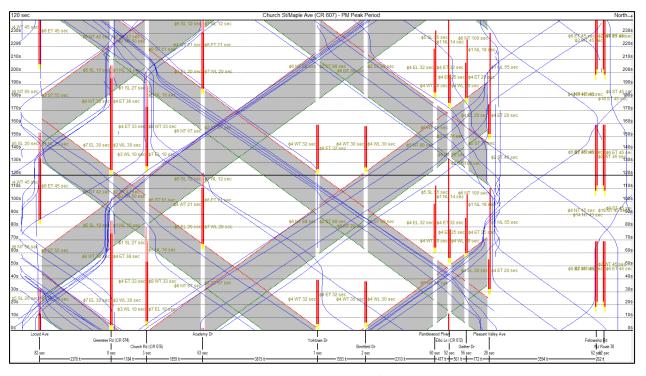
Sample Time-Space Diagram from Tru-Traffic Software - Church St/Maple Ave (CR 607) - PM Peak Period

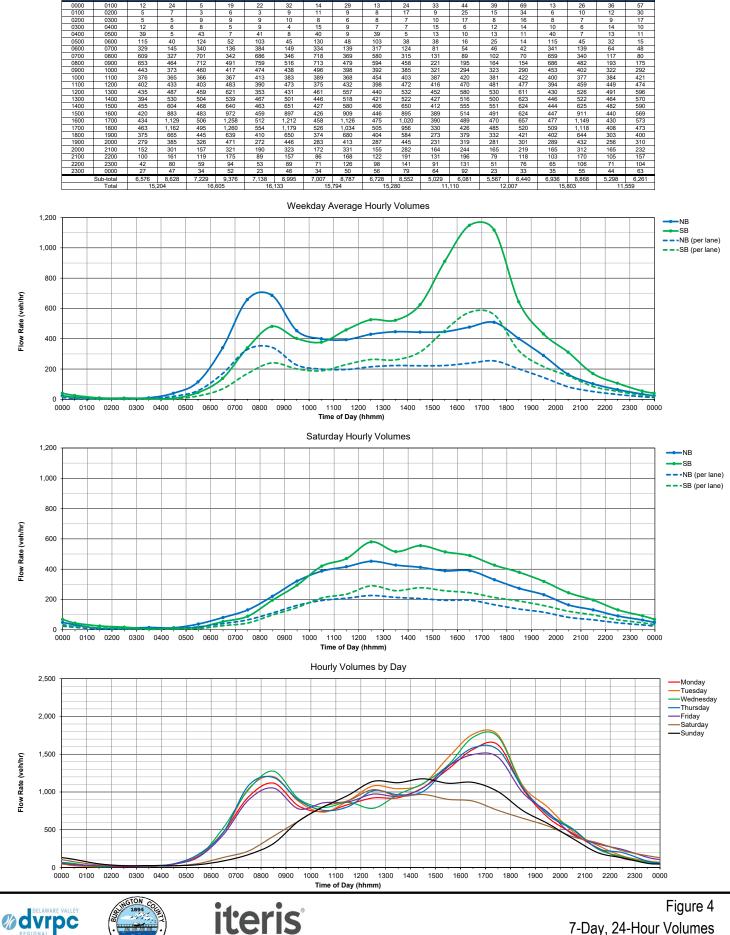
Hourly Volumes - Church St (CR 607) between Ramblewood Pkwy and Birchfield Dr

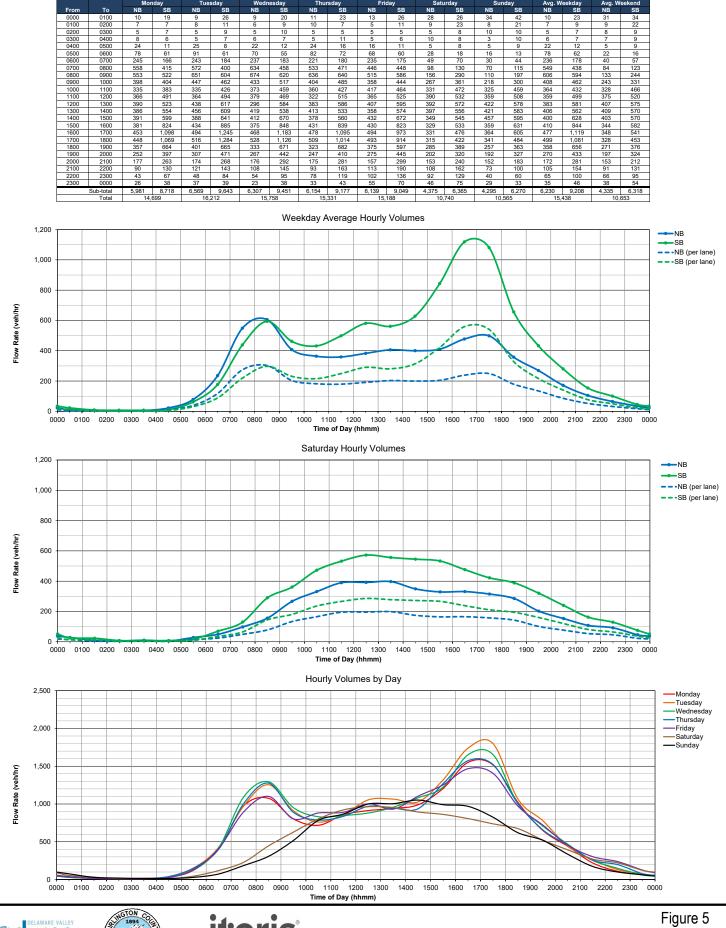
Hourly Volumes - Church St (CR 607) between Academy Dr and Union Mill Rd

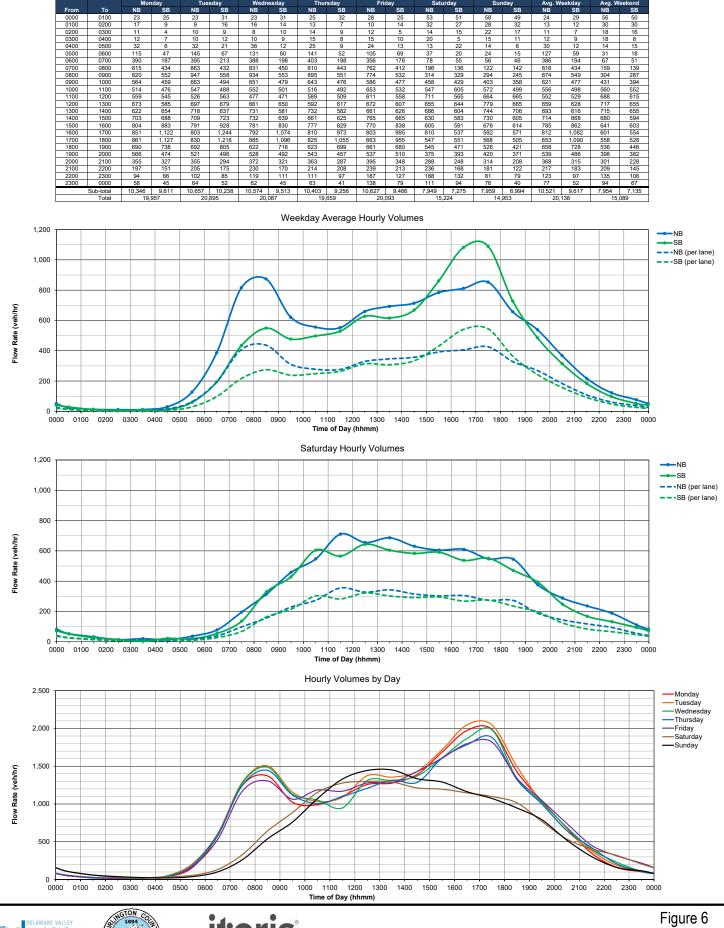
Hourly Volumes - Maple Ave (CR 607) between Greentree Rd (CR 674) and North Locust Ave
